**St. Mary's Church in the village of  
*Labova e Kryqit* in Gjirokstra  
Analyses of the Church's Construction  
Stages, its Age and Some Static Issues**

**Reshat Gega**

**Centre for Albanological Studies, Tirana, Albania.**

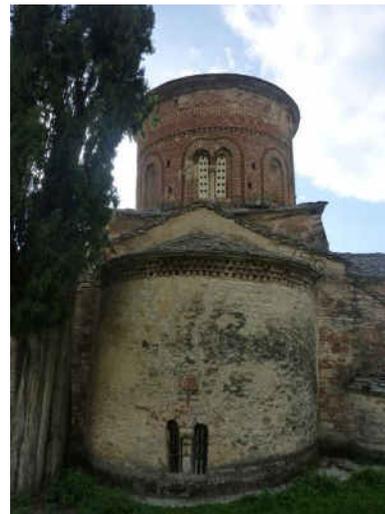
**Fig. 4**

Despite the architectural formulation and all its characteristic features of masonry building techniques, Saint's Mary Church has always been a monument of great curiosity for the visitors due to the noticeable slanting position of the tambour supporting the cupola. (Fig. 4). Many comments and studies have been made about this phenomenon providing different explanations.<sup>26</sup> Many religious people inspired from religious doctrines provide explanations that the tambour of the church is leaning due to the very leaning position of the neck of Saint Mary in many images of her in the church iconography. In fact, the leaning of the tambour and some other deformations of the church have occurred because of an abnormal situation in the sustainability of the church architecture.

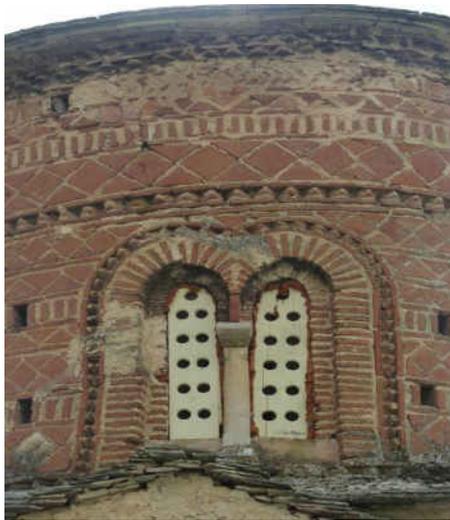
Fig. 5

During 2005-2006 all the interventions in the church's interior and exterior were mainly focused on the treatment of the frescos, different surveys in order to further stretch this treatment, the placement of the panels with holes in the tambour double windows, which evoked the time of the X-XI century, as well as a series of smaller works for the facade. The first sign that we ever noted was the fact that all the panels fixed into the doubled windows, overlooked the first vertical cracks, whose axis coincides with the vertical that has cracked and architecture. (Fig.5) Meanwhile the two other windows, the northern and western ones do not have the cracks.

The first noticeable thing we could detect was the existence of some vertical cracks on the fixed panels of the double windows on the eastern and southern part of the tambour whose axis corresponds to the bigger vertical crack found in the church's architecture. (Fig.5). Meanwhile the other two windows located in the north and west have no such crack. This made us reflect on the reasons why there do exist such vertical cracks only on the windows facing the east and south and why this is connected with the cracks on the church's masonry spreading from the very ground floor of the church? (Fig. 6) Thus, all the reasoning made brought us to the conclusion that there is an ongoing movement in the structure of the church's architecture. The reason why the active cracks are located into the southern and eastern part of the tambour is closely connected to the fact that the direction of the movement from the south to the east creates some strains exactly into this sector of the cylinder as a result of the resistance made in the area which serves to support it. This observation was more than enough to keep looking for some other signs and facts that would reveal some more details regarding this phenomenon and make us reflect on the dynamics of the tambour's continuous movements. Thus, we started observing the interior part of the church.

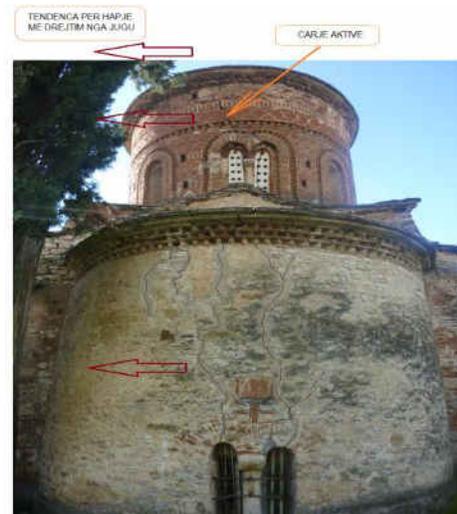
Fig. 6

As mentioned above, there were found some small pieces of material falling from the wall's surface on the southern part of the apses. (Fig.8, 10). On the other hand, due to different stages of construction, there are also some vertical cracks, but at the same time we could also notice cracks which have occurred on the structure of the same phase. This happens due to the overload of the weight due to the gradual displacement of the tambour-cupola body. This evergrowing overweight in this region has exerted its own negative effects on the apse's walls, creating a vertical crack starting from the frame of the dome's roof edges, going to the eastern window of the tambour, falling onto the apses's window and ending onto the ground resulting into another horizontal crack on the cemented pavement which falls vertically with the façade of the apses. This crack is so specific as well as many other cracks and damages on the southern arcade since they give us the idea that its dynamics is restless. (Fig. 6,14)

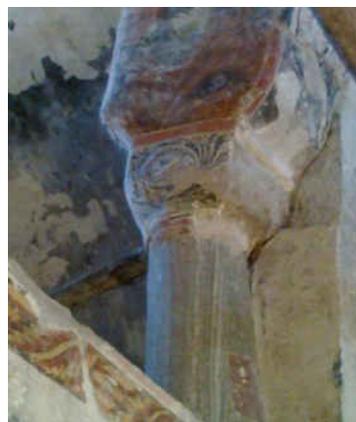
**Fig. 9**

However, this phenomenon of movement does not have the same dynamics in the northern arcade. There is not much of a tendency for a pressing moving force and the cracks are not fresh and very noticeable. Here we can notice a different activity of the arcades' elements. In the second floor coulms, especially in those of the eastern part, one can notice a leaning of the capital towards the inside as it rests with the column's head on the southern part of the section and its opposite side quite open. (Fig.9).

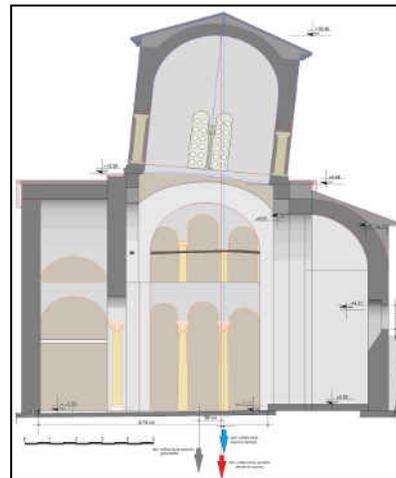
**Fig. 11**

First we did some verifications of the volume geometry of the core area of the church in its interior. (Fig.2). We could approximately determine the dynamics of the movement of the gravity center of the tambour-cupola's body. (Fig.11, 12, 13). Based on the geometry of the layout, we could determine the center of the dome's figure that it is to have on the floor level and drew a comparison with the projection of the current center of the dome, as we checked its vertical position on the floor. There is a displacement onto the south-eastern direction which is unequivocally very disturbing. This kind of movement has resulted in an inclination of 89 cm towards the east and 63 cm towards the south, and has produced a straight movement of 109 cm long, while the interior diameter of the tambour is not even 5 metres. (Fig.2.11.12) This means that the head of the dome has moved from its original position for more than 1 meter and has thus led to a displacement of the center of gravity which influences directly on the destruction of the weight balance in the regions where the tabour rests and this constitutes the region of the cube base formed by the walls onto the two-storey arcades.

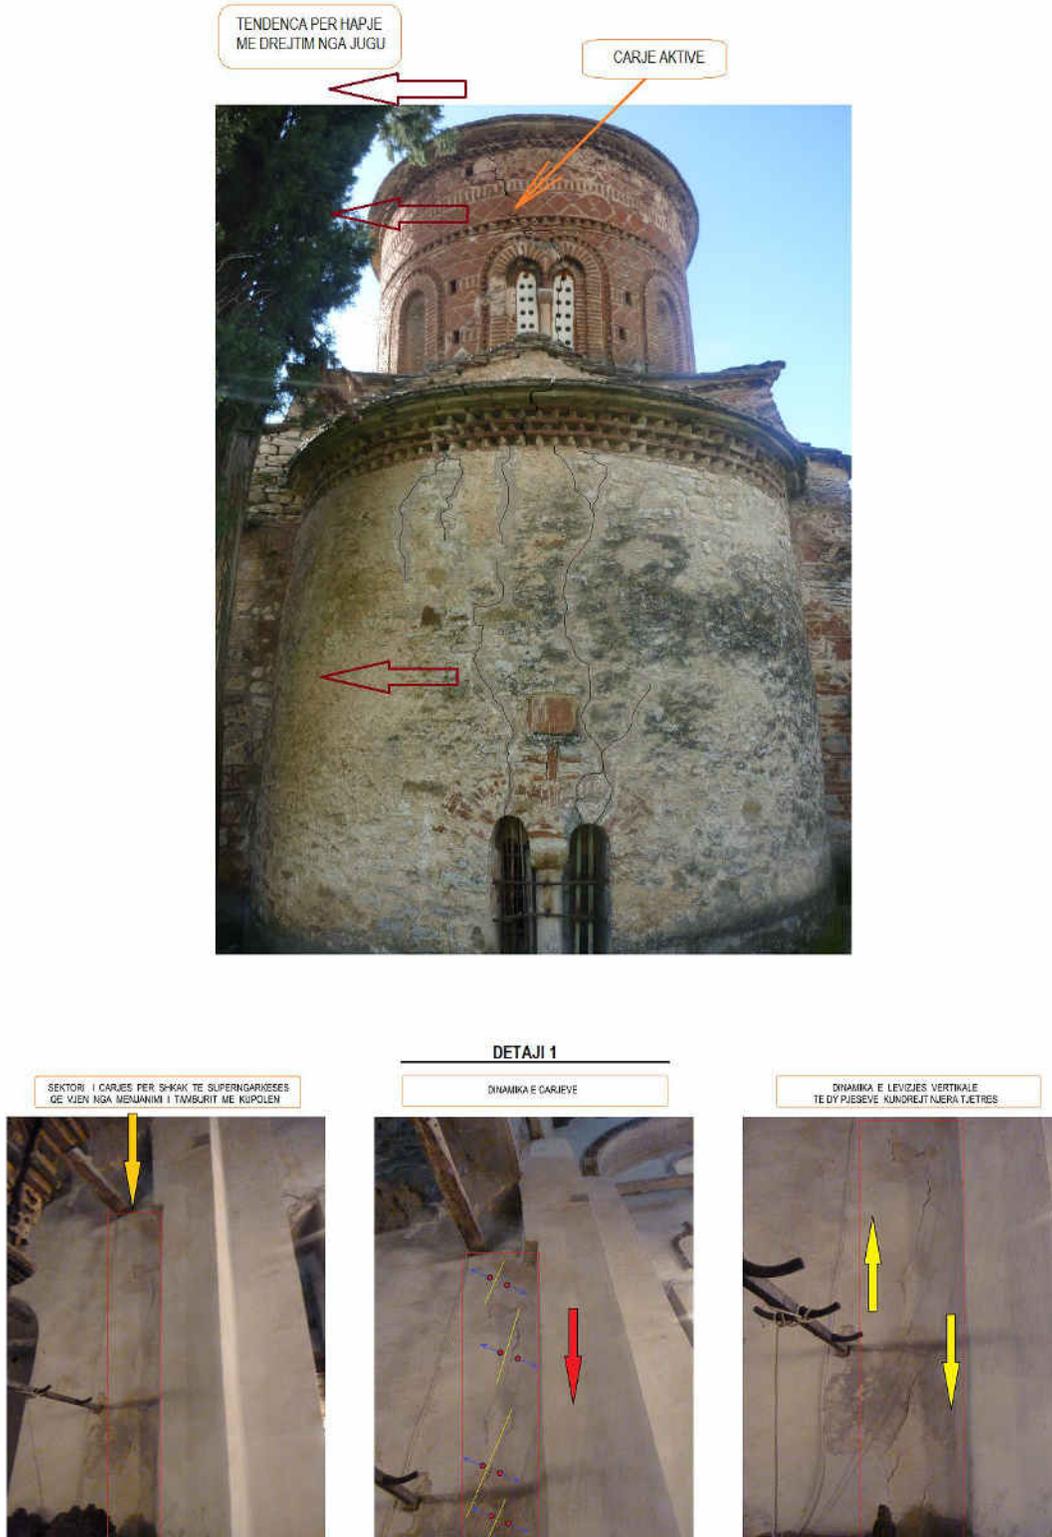
Fig. 15

Another sign which shows the same tendency of this movement, caused by the same negative factors, appears in the south-western pilaster of the core area and this is determined by the arcades of the church's hall. (Fig.15) As aforementioned, attached to these pilasters some pillars were added during another period of construction and the weight of some extra archs falls onto them down the inner periphery of the tambour's base. However there is something very important which needs to be clarified; all the extra arches were built later due to the two-storey arcades and the walls built onto them go up to the point and plan that they would meet the tambour's base. This is most noticeable especially in the inner part of the northern arcade and the archway over did. The changes have taken place one after the other through the passing of time. We will provide a thorough detailed analysis in what follows. (Fig.16)

Meanwhile, we are still dealing with what happens to the south-western pilaster. On its eastern side there is a vertical crack which does not continue for long. It is characterized by continuous interruptions which look like segments starting from high up to the level of the base characterized by a tilt towards the western part. (Fig.15). This is a typical kind of rift found in those cases where two vertical fitting bodies move against each other vertically. Since their masonry does not function as a single body, they can have some independent lowering movements, but as long as they have been plastered without the dividing fugue, their movements lead to deformations on the plastering similar to those of torn paper or cardboard. The whole phenomenon is caused by the vertical overweight onto the legs of the extra archs producing a lowering or "dipping" process far more advanced as compared to the leg or the original pilaster.

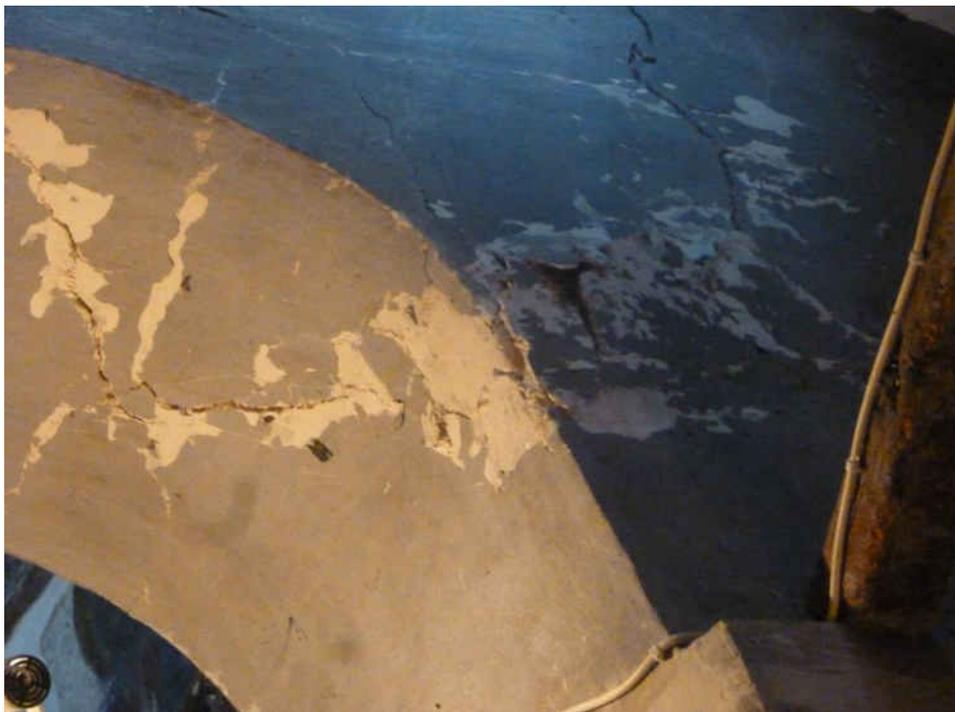
**Fig. 17**

In this case we can easily understand that the original sustaining construction of the tambour-cupola is not able to properly provide the support for the whole load coming from above. Somehow, this is the first and most important defective thing that has brought the whole disorganization of distributing the weight inside a technically correct static scheme. All these verifications make us realize that this part of the church's construction has the biggest difficulties with the evergrowing weight due to the continuous leaning or dislocation of the tambour-cupola's body. Thus, we can notice that some deformations have occurred due to the constant pushing force, structural degradations of the walls' material and the disintegration in the shape of some big bits from the organic connections of the masonry, etc. (Fig.17).

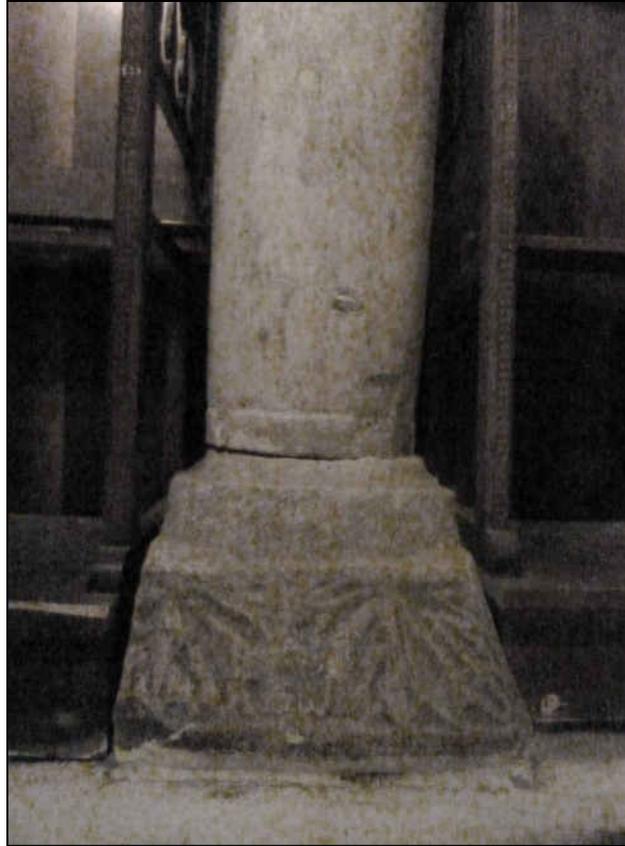
**Fig. 18**

The movement caused by the leaning of the tambour-cupola body has led to the loss of verticality for the major part of the columns of the two-story arcade. One can notice the deviation from the verticality and consequently damages have occurred due to the strain imposed on their bases. Due to this leaning position, the columns have lost their contact and the desired fitting with the sustaining surface of the bases by increasing the overweight for square cm in the contact zone. This condition has led to the break of the edges and the bottom part of the columns and bases as well. (Fig.18)

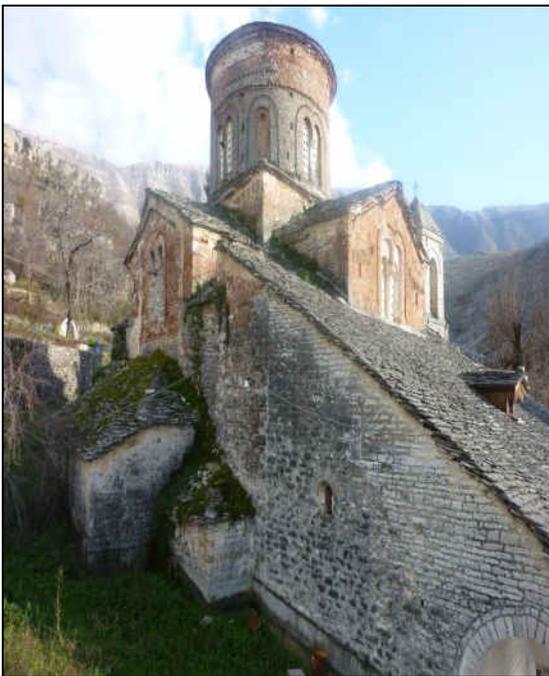
**Fig. 19**

The new constructional volumes made to the church during the first phase, in the northern, southern and western part have caused a certain contra fort and neutralization of the forces tending to push forward, but this amplification factor is only present in the area on the base of the cross written from the outside and down. This means that the reinforcing additives made later, on the sides of the church play no important role in what is happening to its core structure, its tambour-cupola body and its base. (Fig.19).

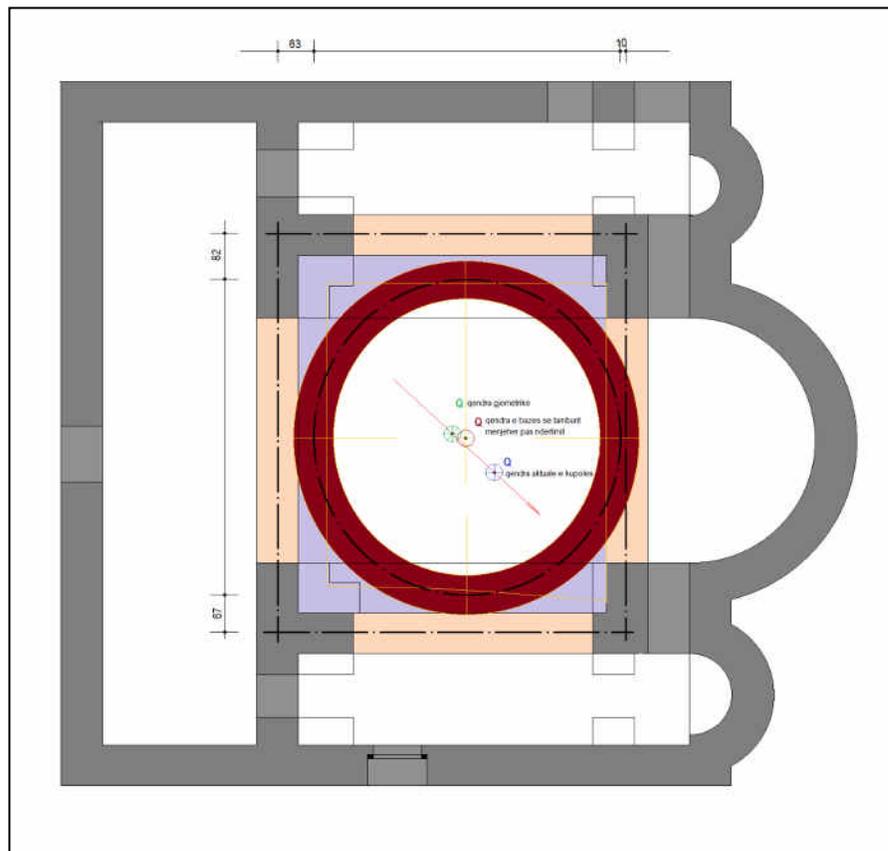
Fig. 21

According to the description given and focusing on the geometrical situation of the church's core area, we have come up to a conclusion which we think constitutes the main reason for all the problems that have led to deformations, loss of verticality, a lowering on the centers of the upper ribs of the cube supporting the tambour base and all the other consequences. (Fig.20) It wasn't difficult to notice that the base of the tambour's cylinder does not fit with the dimensions of the cube's square formed by the walls onto the two-storey arcades. The surface where the tambour's base touches the wall of the cube is very small. (Fig.21).

By all our measurements made, we could evaluate that this surface covers no more than approximately 10 cm on the northern, southern and western side and the thickness of the tambour's wall is 70cm. The discrepancy of the tambour cylinder dimensions with those of the square where it was supposed to be sustained has brought a vertical slide of the tambour since the beginning by taking away the parts where it touched or was based on. This movement of the tambour has exerted its negative effects on the area where we can easily detect the breaking or the bending of the ribs of the base cube, as well as the bending of the corners of the cube with their direction towards the center of the square, by diagonals. (Fig.20, 22). This phenomenon is much more noticeable in the north-eastern and south-eastern corners and a bit less on the two other sides. This has happened because of the way that the shift in the verticality of the tambour's cylinder has occurred with its main tendency towards the south-east direction. However, many other problems are beginning to emerge with the deformation of the tambour's verticality which constantly leads to the deterioration of the static situation in center of the church.
