**St. Mary's Church in the village of  
*Labova e Kryqit* in Gjirokstra  
Analyses of the Church's Construction  
Stages, its Age and Some Static Issues**

**Reshat Gega**

**Centre for Albanological Studies, Tirana, Albania.**

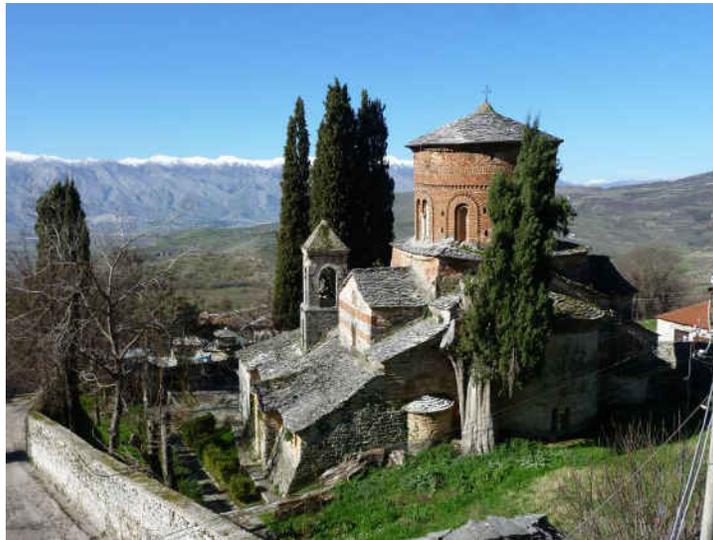
**Fig. 1**

St. Mary's Church, which is situated on the village of Labova e Kryqit (translated as *Labova of the Cross* in English) and falls under the municipality of Libohova, has brought to the repertoire of the Albanian Medieval Architecture the brilliant demonstration of one of the most wonderful architectonic formulation and such a great iconographic program in terms of its functions, the decoration of the interior and exterior that it might be compared to its equals in the elite of this genre in the Byzantine culture worldwide. (Fig.1)

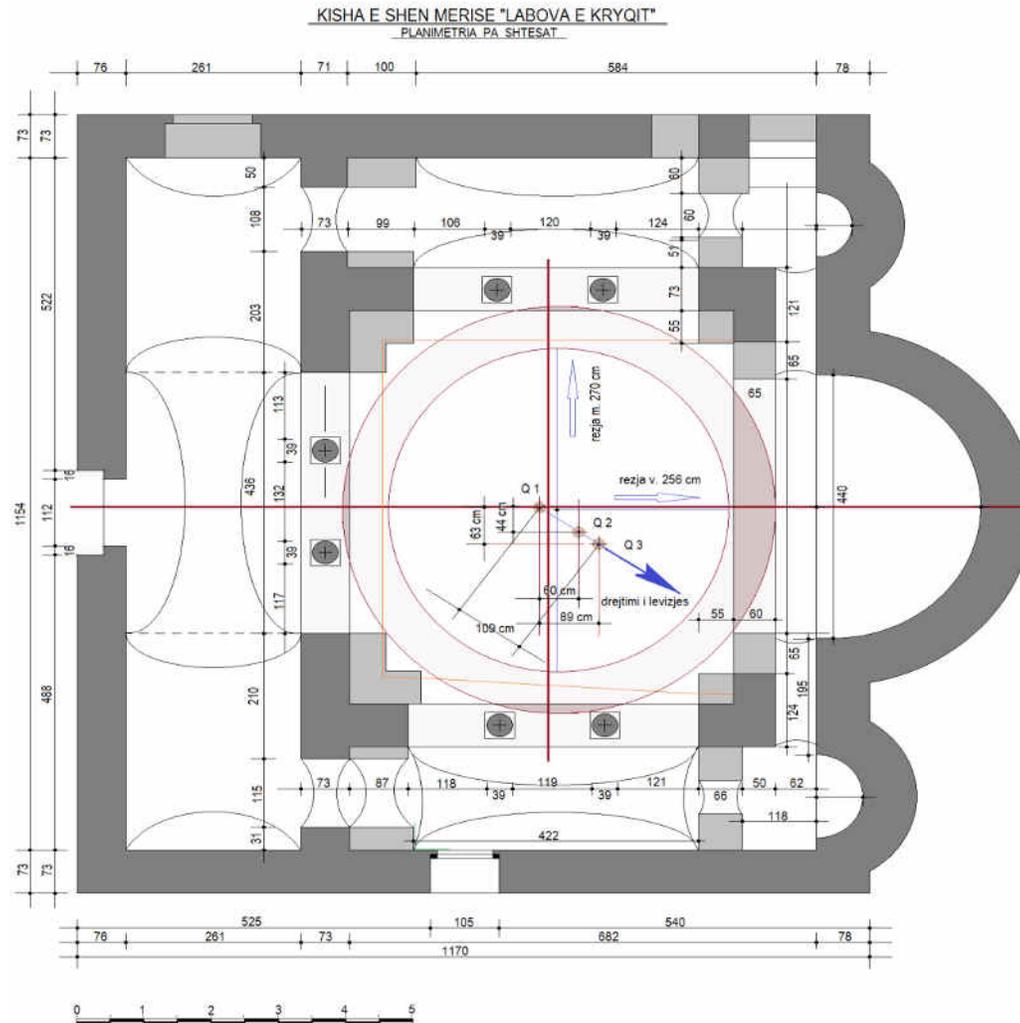
**Fig. 2**

The architectonic type of this church is defined as a cross imprinted with the upper volumes of its arms extending up to the level of the roof. (Fig. 2). Viewed from the perspective of the formulation of the compositional core area which consists of the square structure formed by four columns with three arcades among them to create the cubic base sustaining the tambour of the dome, this type of church provides the best example of a metropolitan style of church and shares similarities with other churches alike. Similar churches are found in

First we did some verifications of the volume geometry of the core area of the church in its interior. (Fig.2). We could approximately determine the dynamics of the movement of the gravity center of the tambour-cupola's body. (Fig.11, 12, 13). Based on the geometry of the layout, we could determine the center of the dome's figure that it is to have on the floor level and drew a comparison with the projection of the current center of the dome, as we checked its vertical position on the floor. There is a displacement onto the south-eastern direction which is unequivocally very disturbing. This kind of movement has resulted in an inclination of 89 cm towards the east and 63 cm towards the south, and has produced a straight movement of 109 cm long, while the interior diameter of the tambour is not even 5 metres. (Fig.2.11.12) This means that the head of the dome has moved from its original position for more than 1 meter and has thus led to a displacement of the center of gravity which influences directly on the destruction of the weight balance in the regions where the tabour rests and this constitutes the region of the cube base formed by the walls onto the two-storey arcades.

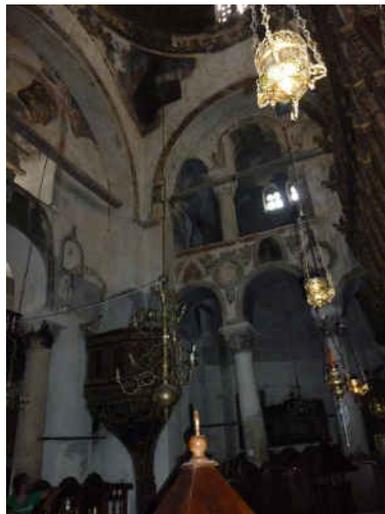
**Fig. 3**

In the previous studies, we can notice some detailed descriptions of the shape of the whole church plan, its volumes and the affinity among them. All these features determine the classification of this church in the group of churches characterized by the shape of a cross inside, covered with archways on the sides of the cross area and with a tambour supporting the dome in the centre of the construction. There has been given a fully detailed information regarding all the elements that constitute the interior of the church, such as the two-storey archads, with two cylindrical columns on each storey, placed all over the northern, southern and western part of the building, the apses and the alter, etc. This kind of construction belongs to the original project of the church and it is mainly a specific characteristic of the naos ideology of church building. This kind of constructional plan draws the attention on the inside construction with its highly suggestive view and its central area most vividly and transparently exposed with the elongated arms on the north and the south and the front part on the west. (Fig.3.)

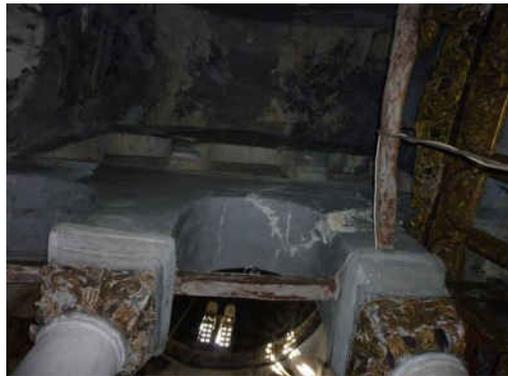
**Fig. 7**

This is the reason why there are more cracks and deformations in the eastern arcade and southern part of the apses. All the craks that were identified in the second floor of the arcade, and the vertical axes of the eastern column, have shown the constant pushing being exerted which can bring about the rupture of the internal connections of the construction material .( Fig. 17). What strikes us most, is the tendency for the the wall to get detached from the column. It is exactly in this region of the southern arcade, on its southern facade where the church's construction and state faces the great problem. It is in this area where all the deformations, deviations and cracks, spurred by the displacement of the gravity centre, are mostly exposed and have exerted a negative influence which is so noticeable on this region of the southern arcade. The current situation of the building and the destruction of the construction material make it easy for us to understand that the destruction made and the loss of the sustaining possibilities of this region prove to be very alarming.
